REQUEST FOR QUOTATION
BUILDING ENVELOPE REHABILITATION AT AMERICAS
PAVILION – BELVEDERE ROOF AND INTERIOR
TZC T 05-2021-02
ADDENDUM #3

SECTION NUMBER	SHEET NAME	ISSUE DATE
287332	PINCHIN - INVESTIGATION OF MOULD GROWTH – OTTER VIEWING AREA	2021-02-19

Toronto Zoo retained Pinchin Ltd. (Pinchin) to perform an investigation of potential mould growth in the Africa Restaurant, the Otter Viewing Area and the Beaver/Otter Pump Room at Toronto Zoo located at 361A Old Finch Avenue, Toronto, Ontario following identification of water damage and possible mould growth. The investigation, conducted on February 8, 2021 addressed the basement of the Africa Restaurant, Otter Viewing Area and the Beaver/Otter Pump Room and included interviews, inspections, and testing.

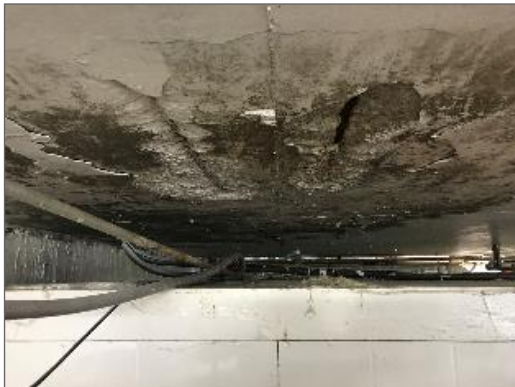
- **Basement of African Restaurant:**
 - Mould growth on the eroded and wet concrete ceiling above the Walk-in Cooler, some rebar were exposed and rusty where concrete ceiling was eroded.

The water damage and mould growth identified on the concrete ceiling above Walk-in Cooler in the Basement of the African Restaurant is likely caused by the leak and/or condensation/moisture from the refrigeration and freezer units present above on the Main Floor. The cause of the water damage in the staff room ceiling space and Drinking Fountain area in the Basement of the African Restaurant could not be identified. The likely cause of water damage and mould growth identified in the Otter Viewing Area is

Photo 1 - Mould growth and eroded concrete ceiling above Walk-in Cooler in the Basement

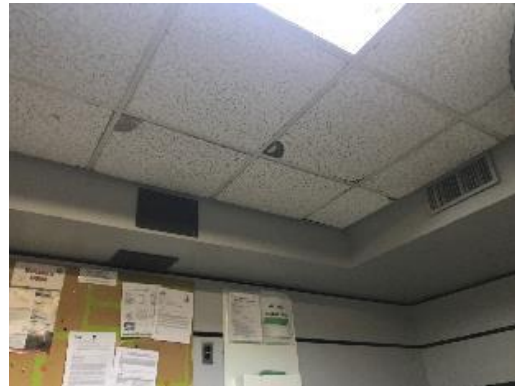
- Mouldy/water damaged/wet ceiling tiles at several locations in the Staff Room and Office Space.
 - One missing ceiling tile in Office Space.
- **Otter Viewing Area:**

Photo 2 - Water damaged/mouldy ceiling tiles in the Staff Room

- d. Following EACO Level 1 mould procedures in conjunction with O.Reg 278/05 Type 1 asbestos procedures remove and dispose of mouldy/water damaged/wet ceiling in the Staff Room and Office Space.

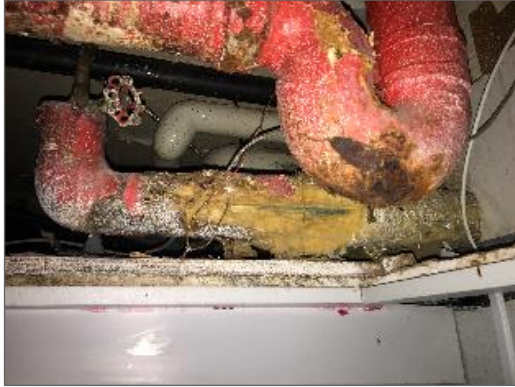
- Mouldy drywall ceiling along the east wall in the Staff Room
 - Mouldy and water damaged pipe insulation in the Drinking Fountain area and in the ceiling space of the Staff Room.

Photo 3 - Mouldy pipe insulation in ceiling space in the Staff Room

- c. Following Level 2 mould procedures in conjunction with O.Reg 278/05 Type 2 asbestos glove bag procedures remove and dispose of mouldy and water damaged pipe insulation in the Drinking Fountain area and in the ceiling space of the Staff Room.

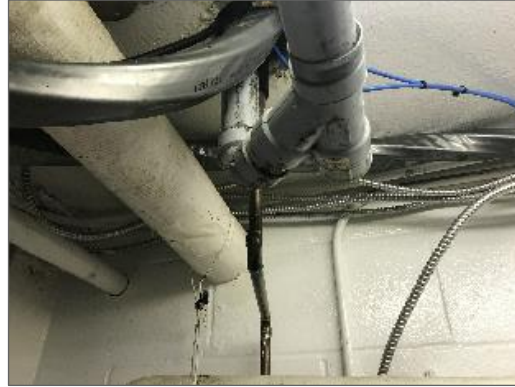
Photo 4 - Mouldy/water damaged pipe Insulation in Fountain Drink area

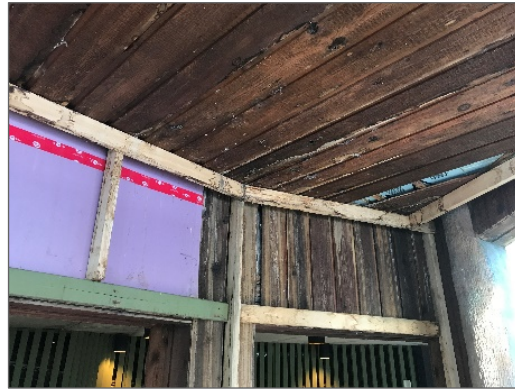
- Mould growth and water damage on wooden ceiling and bulkhead wall finishes along the south wall.
 - Water stained foam insulation on the ceiling at northwest corner and bulkhead along south wall.

ongoing roof leaks in the Otter Viewing Area. The water damage and mould growth identified on pipe insulations in the Beaver/Otter Pump Room is likely caused by condensation of the pipes and/or spray from the pumps and elevated humidity in the room. Further investigation of water damage and necessary repairs in these areas is recommended. Pinchin's Building Science Group would be pleased to assist with this work, if required.

Photo 6 - Mouldy/water damaged wood ceiling and bulkhead wall in Otter Viewing area

In Otter Viewing Area mould growth and water damage was identified on wooden ceiling and wooden bulkhead wall finishes spanning the interior facing along the south wall. Stained foam insulation was identified on the ceiling at northwest corner and bulkhead along south wall. Elevated moisture content was measured on concrete floor near northwest corner.

- b. Remove and dispose of stained foam insulation on the ceiling northwest corner and bulkhead along south wall.
6. Following Level 2 mould procedures in conjunction with Type 3 asbestos procedures remove and dispose of mouldy and water damaged insulation on the pipes and pipe fittings in the Beaver/ Otter Pump Room as outlined on drawing 2.

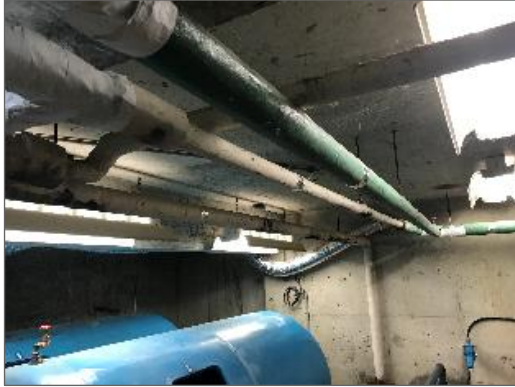
- Elevated moisture content was measured on concrete floor near northwest corner.
- **Beaver/Otter Pump Room:**
 - Mouldy and water damaged insulation on most of the pipes and pipe fittings.

Photo 7 - Mouldy/stained pipe insulation in Beaver/Otter Pump Room

Mouldy and water damaged insulation was identified on most of the pipes and pipe fittings in the Beaver/Otter Pump Room. Strong musty odour was noticeable inside and immediately outside the room.

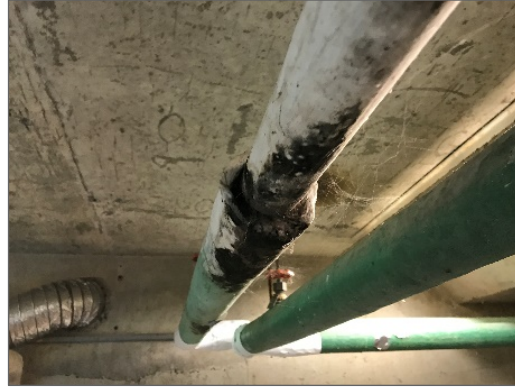
Photo 8 - Mouldy/stained pipe insulation in Beaver/Otter Pump Room
