REQUEST FOR QUOTATION
BUILDING ENVELOPE REHABILITATION AT AMERICAS
PAVILION – BELVEDERE ROOF AND INTERIOR
TZC T 05-2021-02
ADDENDUM #3

SECTION NUMBER	SHEET NAME	ISSUE DATE
287332	PINCHIN - INVESTIGATION OF MOULD GROWTH – OTTER VIEWING AREA	2021-02-19

Toronto Zoo retained Pinchin Ltd. (Pinchin) to perform an investigation of potential mould growth in the Africa Restaurant, the Otter Viewing Area and the Beaver/Otter Pump Room at Toronto Zoo located at 361A Old Finch Avenue, Toronto, Ontario following identification of water damage and possible mould growth. The investigation, conducted on February 8, 2021 addressed the basement of the Africa Restaurant, Otter Viewing Area and the Beaver/Otter Pump Room and included interviews, inspections, and testing.

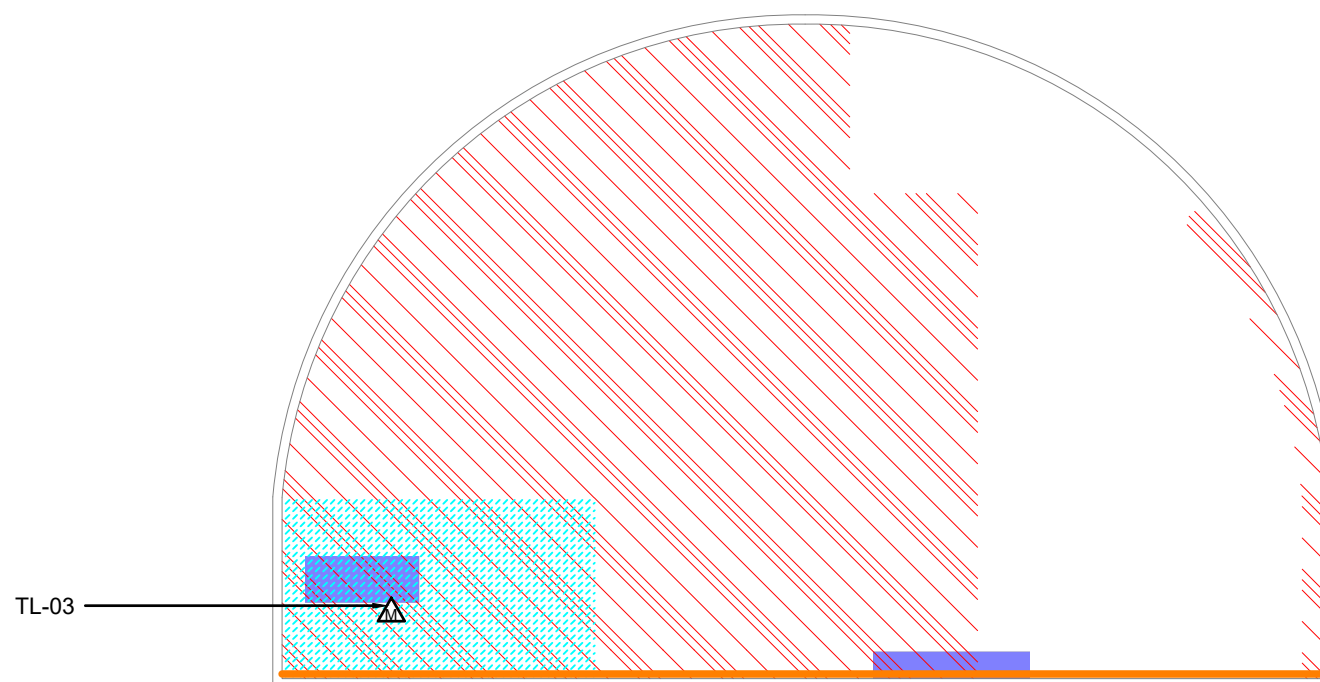
- Mould growth and water damage on wooden ceiling and bulkhead wall finishes along the south wall.
 - Water stained foam insulation on the ceiling at northwest corner and bulkhead along south wall.

WATER STAINED WOODEN CEILING FINISHES

1. Communicate the findings of this report as necessary.
2. Retain a building science professional to perform further investigation into the source of the water damage and make repairs as required. Pinchin's Building Science Group would be pleased to assist with this work, if required.
